GEOTECHNICAL INVESTIGATION REPORT

EMWD LOS ALAMOS HILLS PIPELINE PROJECT

City of Murrieta, Riverside County, California

CONVERSE PROJECT No. 22-81-144-02

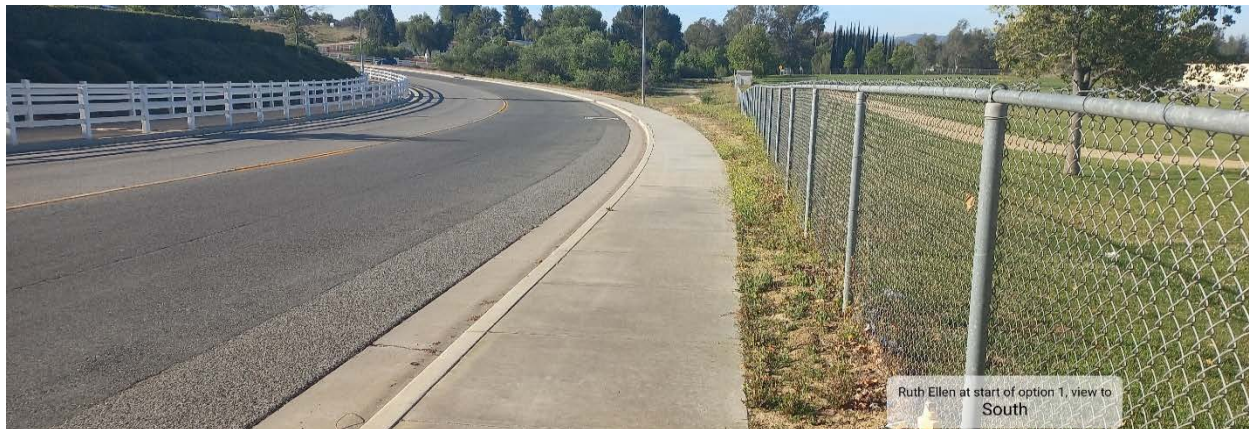
Photograph No. 1: Ruth Ellen Way at beginning of pipeline alignments BH-02, facing south.

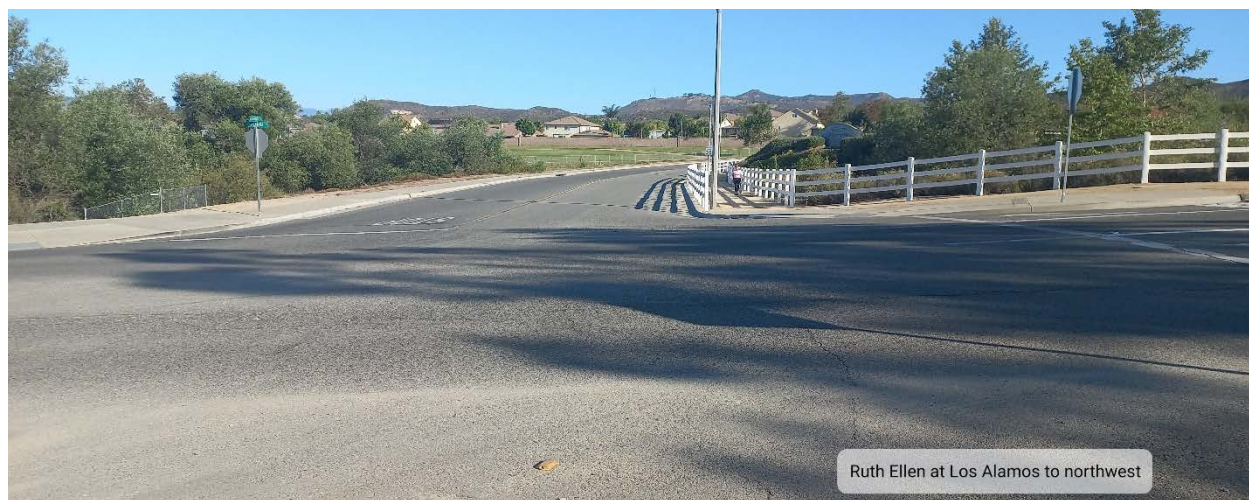
Photograph No. 2: Ruth Ellen Way at Los Alamos Road, facing north.

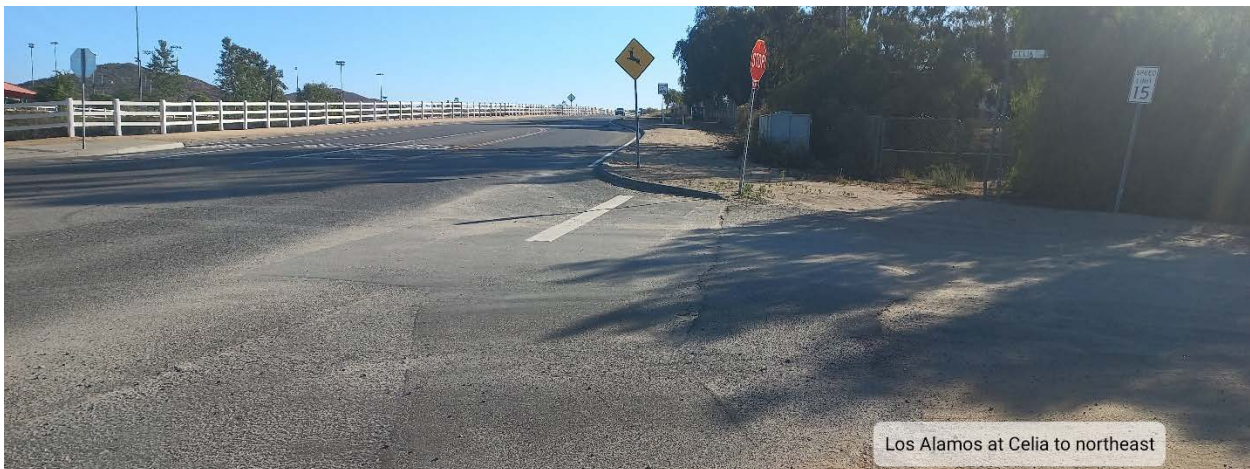
Photograph No. 3: Los Alamos Road at Ruth Ellen Way, facing northeast.

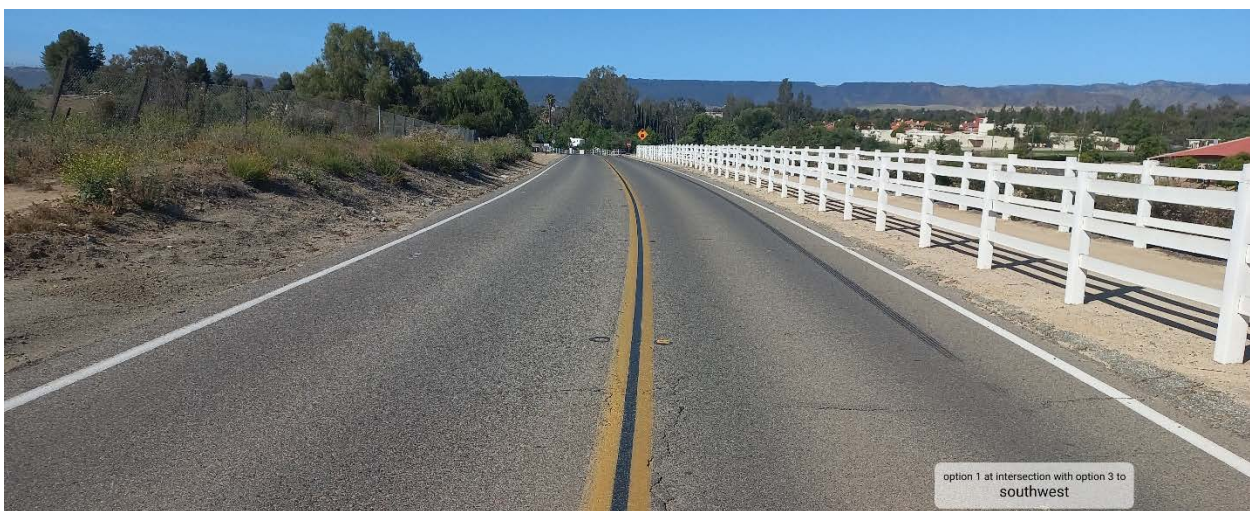
Photograph No. 4: Los Alamos Road BH-15, facing southwest.

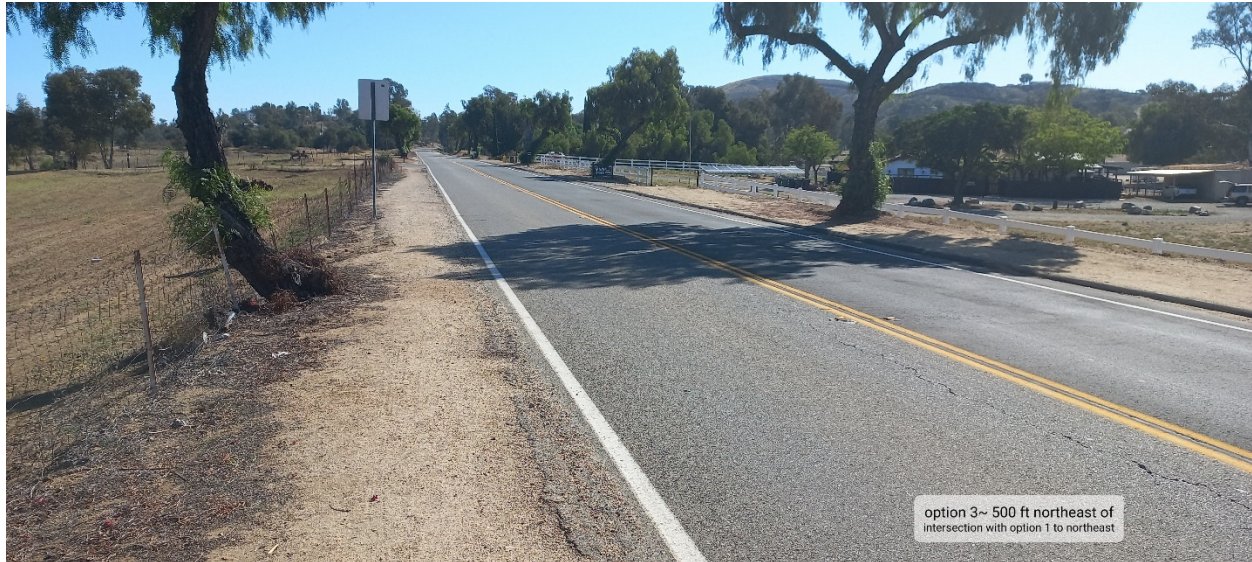
Photograph No. 5: Los Alamos Road (BH-13), facing northeast.

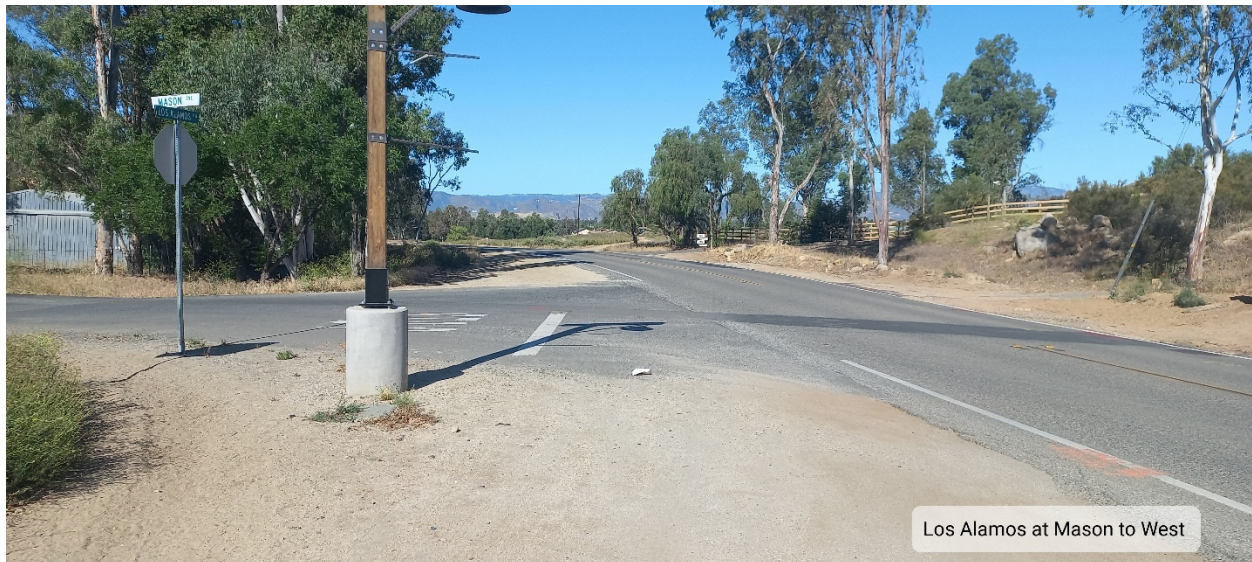
Photograph No. 6: Los Alamos Road at Mason Avenue (BH-12), facing southwest.

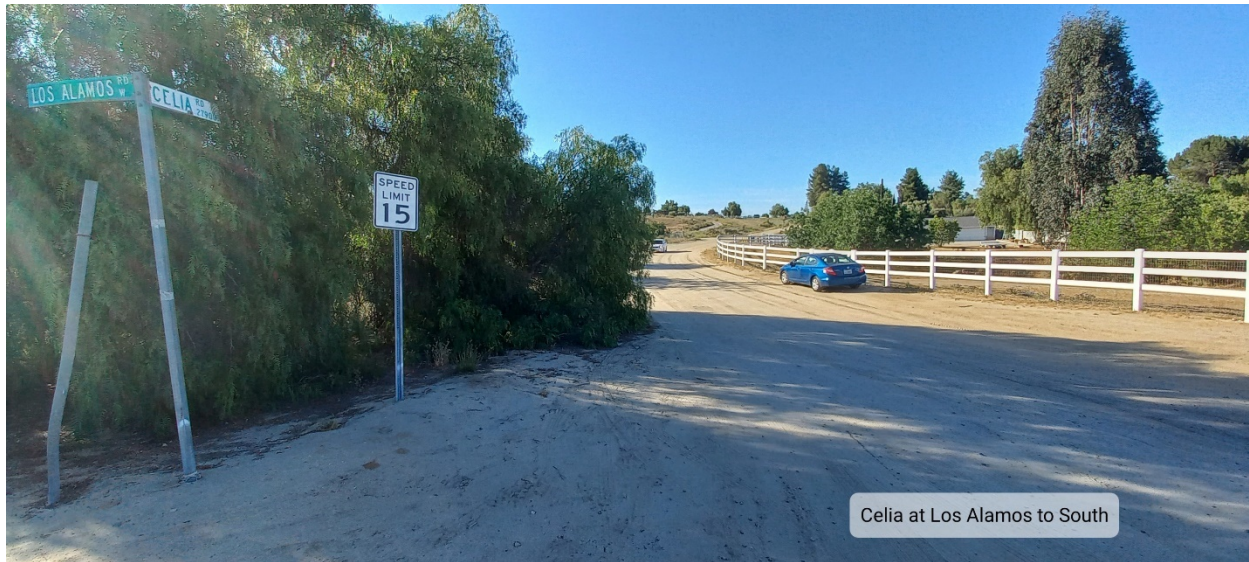
- Bounded on both sides by residential horse property.
- Graded dirt road with single lane in each direction. The width of the road is approximately 25 feet.
- The posted speed limit sign is 15 miles per hour (mph).
- No overhead or overhanging streetlights.
- Light traffic was observed.

Photograph No. 7: Celia Road at Los Alamos Road BH-03, facing southeast.

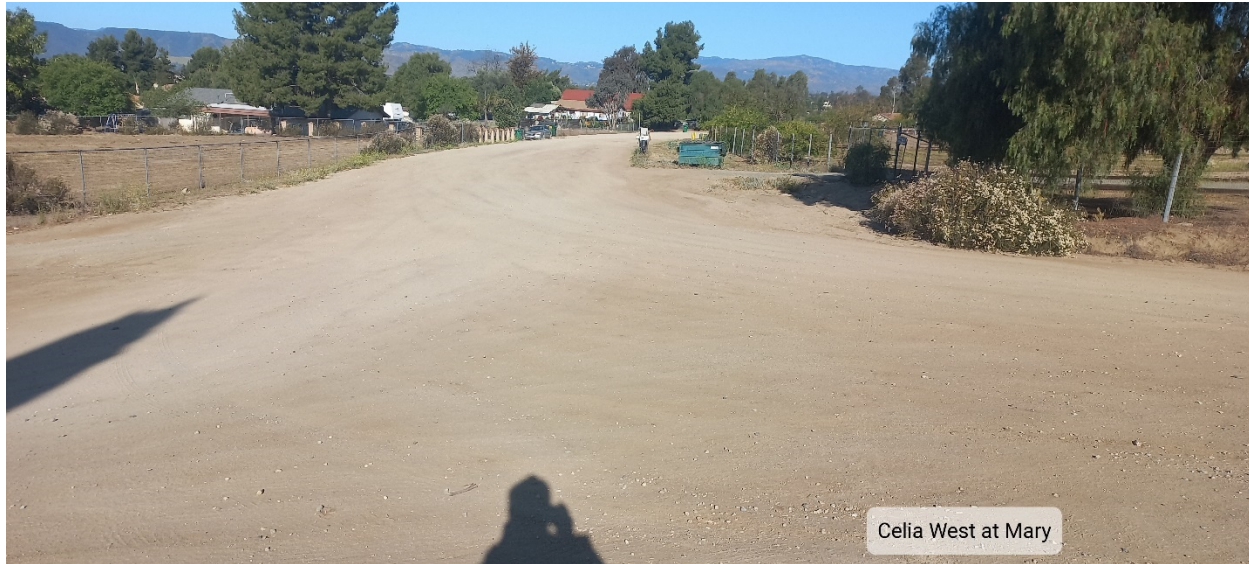
Photograph No. 8: Celia Road at Mary Place BH-05, facing west.

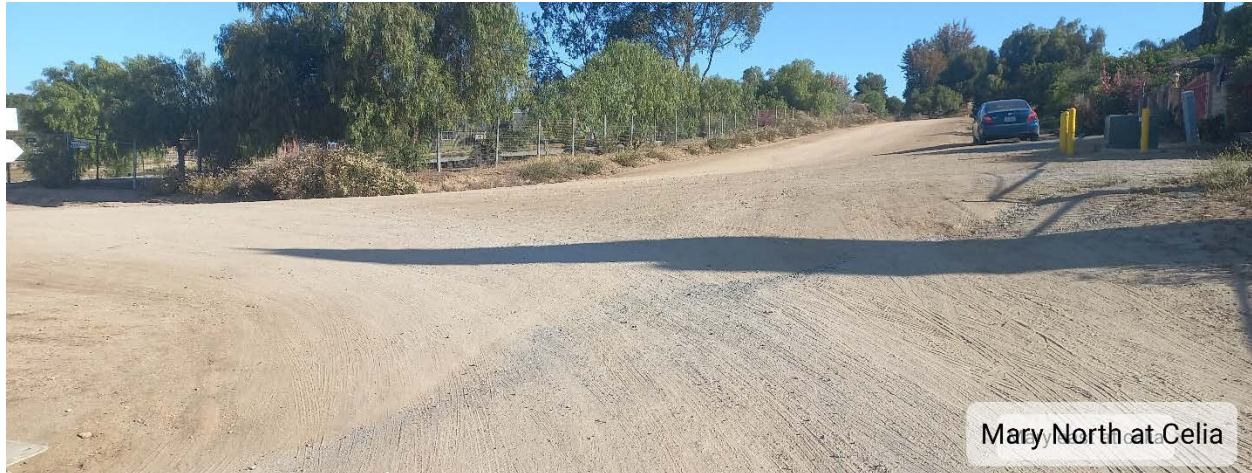
- Graded dirt road with single lane in each direction. The width of the road is approximately 25 feet.
- Light traffic was observed.
- No professional traffic control required.
- Drilling required the closure of the shoulder.
- Refer to Photograph Nos. 9 through 10.

Photograph No. 9: Mary Place at Celia Road, facing north.

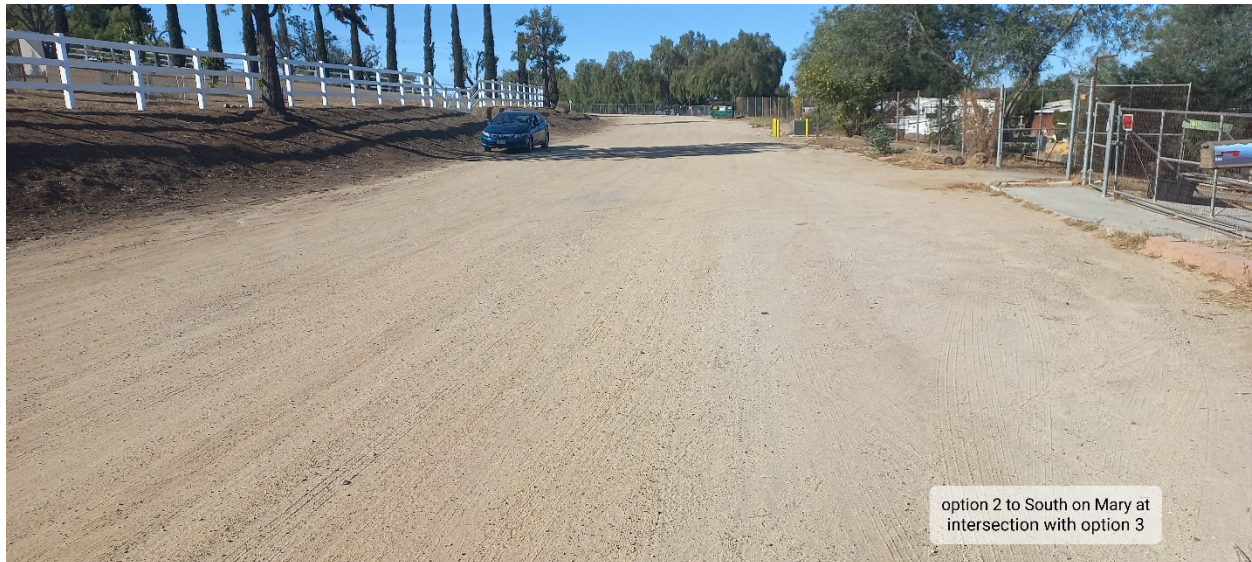
Photograph No. 10: Mary Place (BH-07), facing southwest.

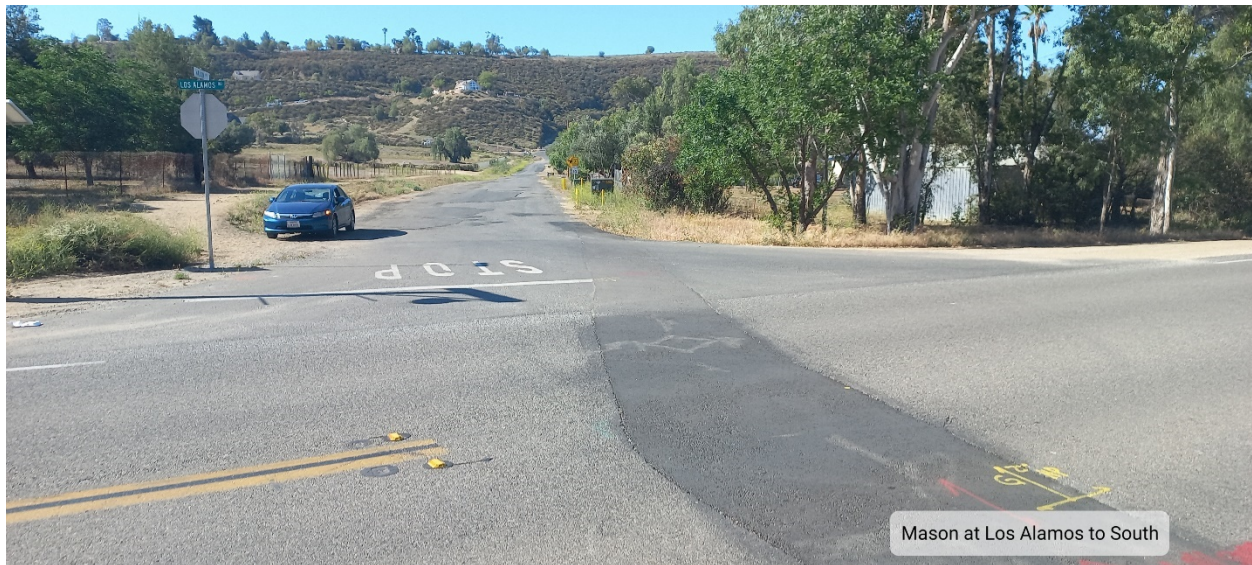
- Heavily worn paved road with single lane in each direction. The width of the road is approximately 15 feet.
- The posted speed limit sign is 10 miles per hour (mph).
- No overhead utilities or streetlights.
- Light traffic was observed.
- No professional traffic control was required.
- Drilling required the closure of the shoulder.
- Refer Photograph Nos. 11 and 12.

Photograph No. 11: Mason Avenue at Los Alamos Road, facing south.

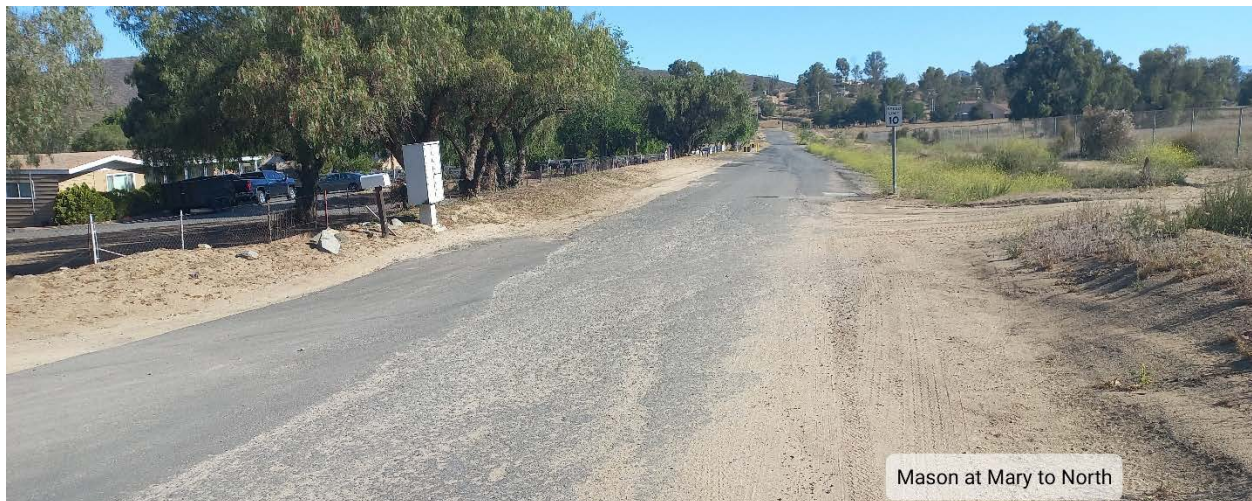
Photograph No. 12: Mason Avenue at Mary Place, facing north.
